**Loss of Pitch Control During Takeoff  
Air Midwest Flight 5481  
Raytheon (Beechcraft) 1900D, N233YV  
Charlotte, North Carolina  
January 8, 2003**

**Aircraft Accident Report**  
**NTSB/AAR-04/01**

**Air Midwest Flight 5481**

**Raytheon (Beechcraft) 1900D, N233YV**

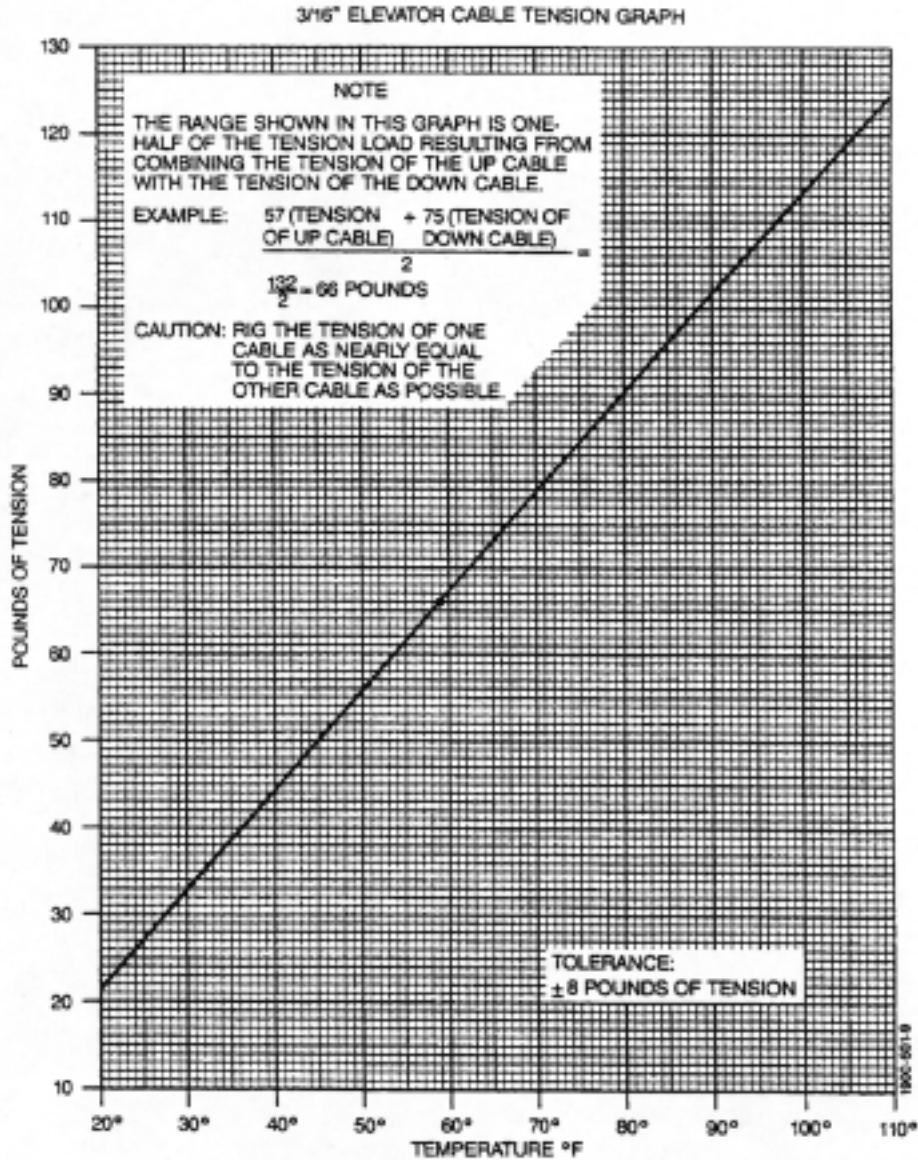
Figure 203 - Elevator Cable Tension Graph

<sup>32</sup> Figure 203 was an elevator cable tension graph included in section 27-30-02 of the Beech 1900D AMM. The graph did not contain instructions on how to take a temperature reading.

- Step q refers the mechanic to the elevator cable tension graph (figure 203) in section 27-30-02 for performing cable tensioning, but no instructions were given regarding whether the airframe, outside air, or cable temperature was to be taken when determining the amount of cable tension; whether the flight compartment cabin temperature gauge or an outside air temperature gauge was to be used in determining the temperature; and what type of device was to be used to measure cable tension.
